RECENT EXPERIENCE ON TROUBLE SHOOTING OF 4.4 K REFRIGERATOR DURING LONG RUN OF LINAC

Anup Choudhury, J Chacko, S Kar, M Kumar, S Babu, J Antony, Raj Kumar & T S Datta
Inter University Accelerator Centre, New Delhi – 110067

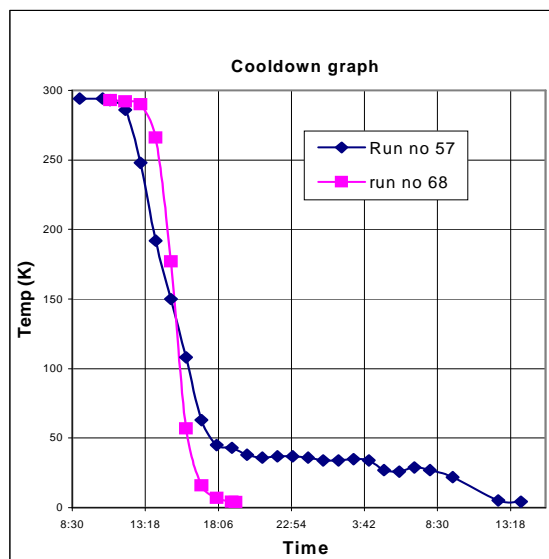
during the prolonged cooldown period the dewar temperature used to be ~25-30K (Fig-1) for very long time. This temperature stagnation conjectured at possible hydrogen contamination in the vacuum jacket of transfer line connecting dewar and the cold box. A closer look at this 2 core transfer line revealed that this line was slightly colder than its surrounding and also there was some small frosting at the vacuum jacket bends. All these observations prompted us to believe that there was indeed vacuum degradation due to hydrogen desorption at the transfer line after ~13 years of operation.

Figure 1: Cooldown comparison graph.

The transfer line was evacuated for two weeks with continuous heating of the vacuum jacket and ultimate vacuum of $<5 \times 10^{-6}$ torr was obtained. This vacuum conditioning reduced the cooldown time drastically from 30 hrs to 12 hrs. Figure-1 gives a comparative assessment of the time improvement in the cooldown time after the vacuum conditioning. The cooldown time was further improved by an additional 2 hrs by optimising the helium gas flow rates through different channels.

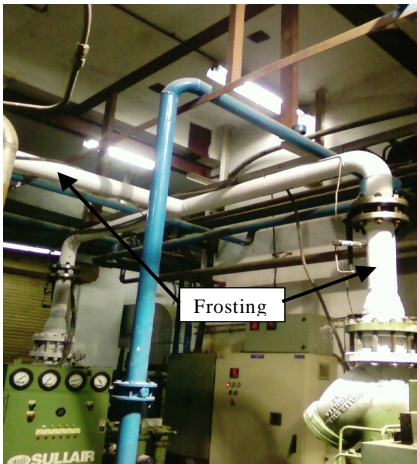
During one of the early 2010 runs it was observed that the liquid nitrogen consumption has shot up dramatically to almost double the quantity compared to earlier stable runs and also we could see the whole of the return line (~80 mts long) to the compressor suction completely frosted (Fig-2) during the liquid production phase of the run. The problem was identified to be a blockage of one

of the 6 lines in heat exchanger 1 (HX-1) in the discharge side resulting in a lower surface area available for the cold return gas to exchange all the cold enthalpy. The discharge line was therefore heated and purged with dry nitrogen gas to drive away the water in the line. But the problem of excess LN₂ consumption persisted along with frosting of the entire suction line. Then a dew point measurement check of the discharge lines showed a lot of moisture (-30 degC) in the charcoal beds (80K and 20K) and GMS bed in the compressor room. Such high level of moisture soaking in all the three charcoal beds pointed to a moisture contaminated helium gas charge earlier, and was blocking HX-1 slowly and repeatedly during operational cooldown.

Figure 2: Frosting in suction line.

To solve the problems all the three charcoal beds and process lines inside cold box were purged with hot (~100°C) dry pure nitrogen from in-house LN₂ plant. The drying process ended after 10 days when the dew point of the outlet gas was better than -70 deg C. Then the whole of the helium circuit lines were thoroughly pumped and purged with dry helium from the tanks.
