1.4.2.2 Femto second Laser Ablated High Resolution Inductively Coupled Plasma Spectrometry (LA-HR-ICP-MS)

1.5 LOW ENERGY ION BEAM FACILITY (LEIBF)

1.6 LOW ENERGY NEGATIVE ION IMPLANTER FACILITY

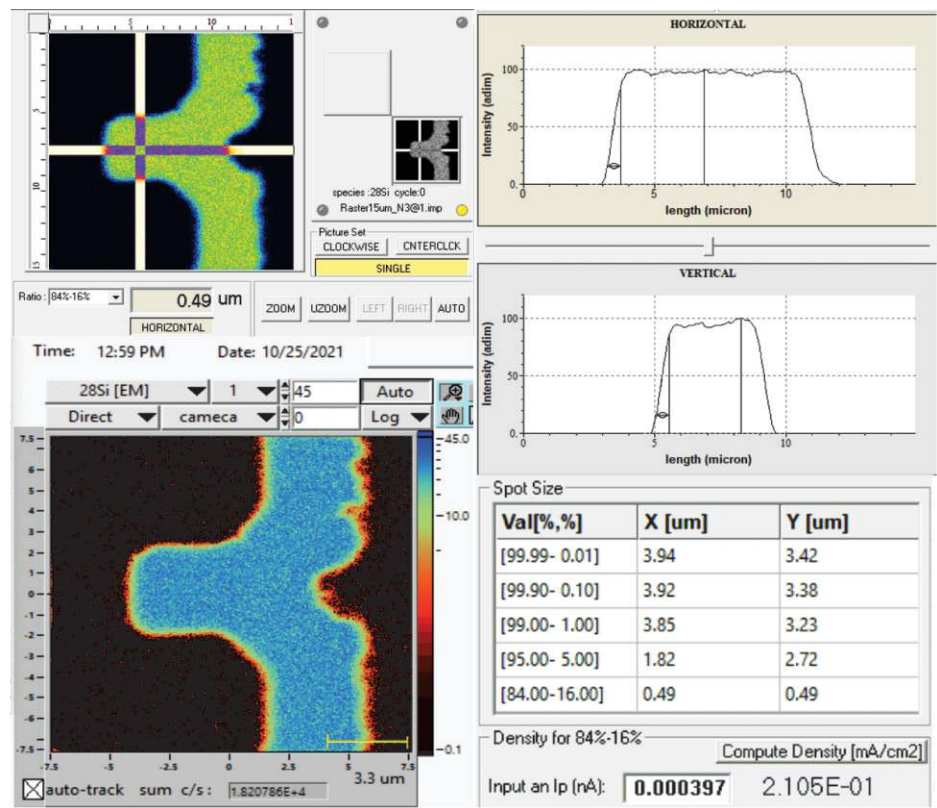
Figure 3: Determination of beam diameter of Cs⁺ primary beam.

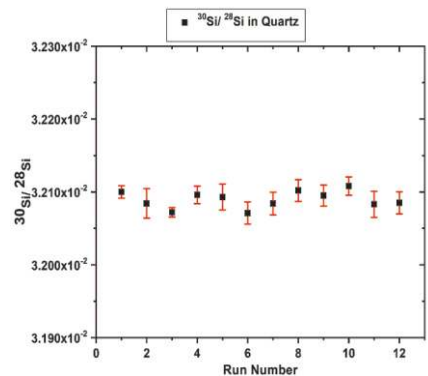
Various Isotopic analyses were carried out to determine the internal and external reproducibility of the measurements. Oxygen and silicon isotopic analyses were done in quartz samples and magnesium isotope analysis was done in olivine samples. Silicon isotopic ratios for 12 spots are shown in figure 4. The internal and external reproducibilities were found to be < 0.05 % for all the isotopic analysis for 12-14 spots having 10 cycles of 4 second integration time each.

Figure 4: Silicon isotope analysis in quartz.

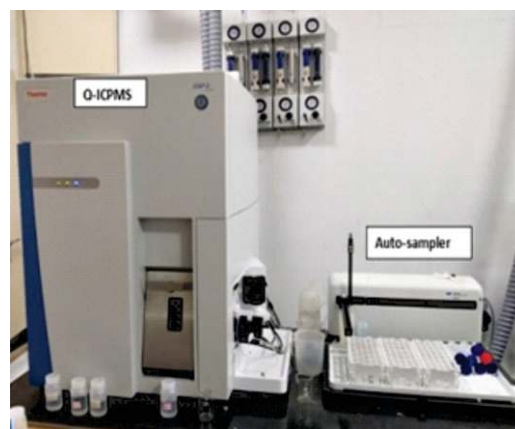
Figure 6: Q-ICPMS instrument with auto sampler.

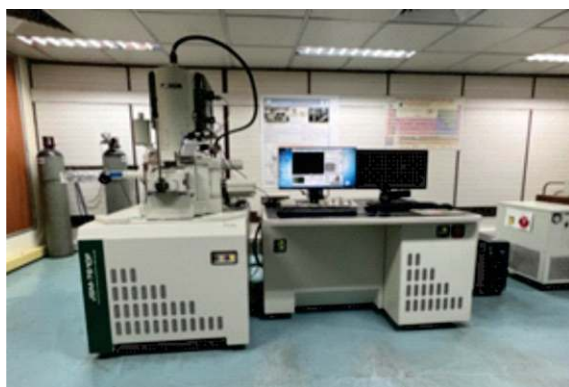
The JEOL Field Emission–Scanning Electron Microscope (FE-SEM, JSM-7610F) installed in our laboratory at IUAC is a versatile high resolution scanning electron microscope as shown in figure 7. Apart from the high-resolution surface imaging using Secondary and Backscattered electrons detection, this machine has analytical capabilities such as Energy dispersive X-ray spectrometer (EDS) for elemental analysis, Electron backscattered diffraction (EBSD) for crystalline information and *Cathodoluminescence (CL)* for optical analysis of the samples.

Figure 7: FE-SEM (JEOL-JSM-7610F).

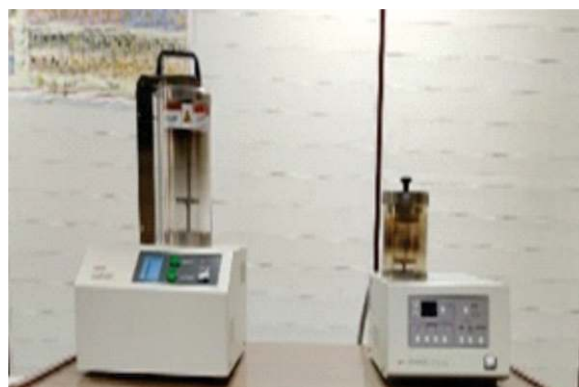
For coating of non-conductive samples, we have facility of two compact and automatic rotary pumped coaters (Carbon (EC-32010CC) and Platinum sputter (JEC-3000FC)) as shown in figure 8. The FE-SEM with CL facility competently performed all-round the year except EDS and EBSD. More than 30 users from 17 Universities/Institutes all over India have utilized the facility. Following types of samples were analysed from different fields for surface topography.

Figure 8: Carbon and Platinum Coater.

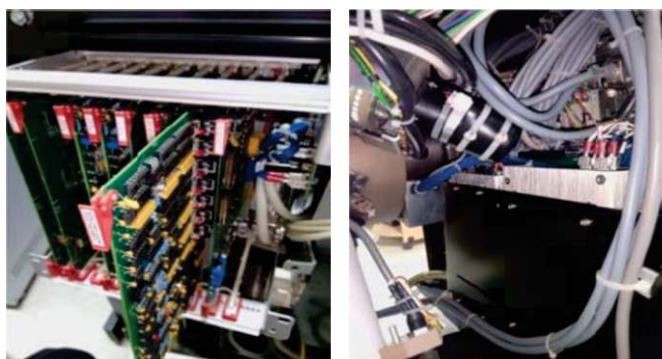
- The X-ray tube was found off and the chiller showed fault. This was because chiller was not working properly. Chiller was repaired with the help of AC group.
- XRF system was not turning on, there was a problem in switching on the power. There was a problem with the power supply SMPS LPQ-172. The control board and turret motor were replaced with newer ones, as shown in figure 9.
- The screws of pellet pressing machine were found to be broken. The machine was repaired with the help of IUAC workshop.

Figure 9: Maintenance related to WD-XRF.

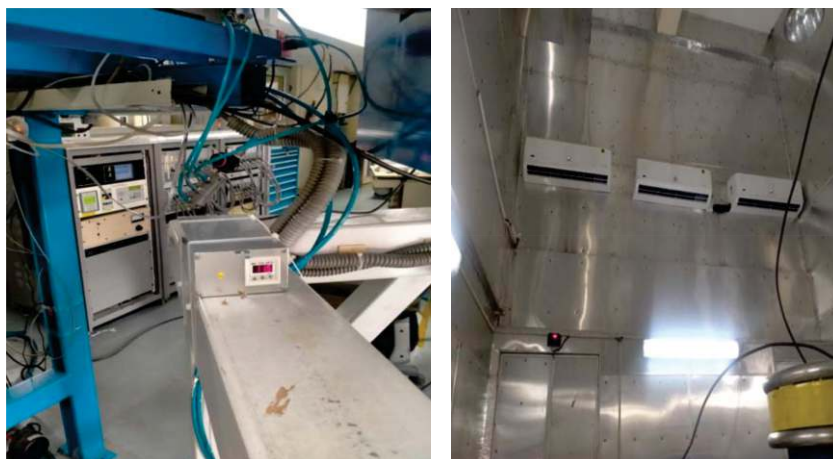
Figure 2: (a) The water flow meter installed in the beam line. (b) 3 AC units installed in the ion source room.

- The installation of three split AC units in the ion source. The additional one unit was kept for standby.
- The cleaning of vacuum pumps installed in pre-analysis section followed by leak detection tests
- The installation of flow meter with proper interlocks to avoid rusting of the electronic components of water cooled high power magnetic devices
- The voltage multiplier stacks of 400 kV high voltage power supply were thoroughly cleaned using de-ionized water to ensure greater beam stability during regular user experiments
- The scheduled maintenance by various support labs to confirm proper functioning of beam transport system, vacuum components and remote operation of the LEIBF.

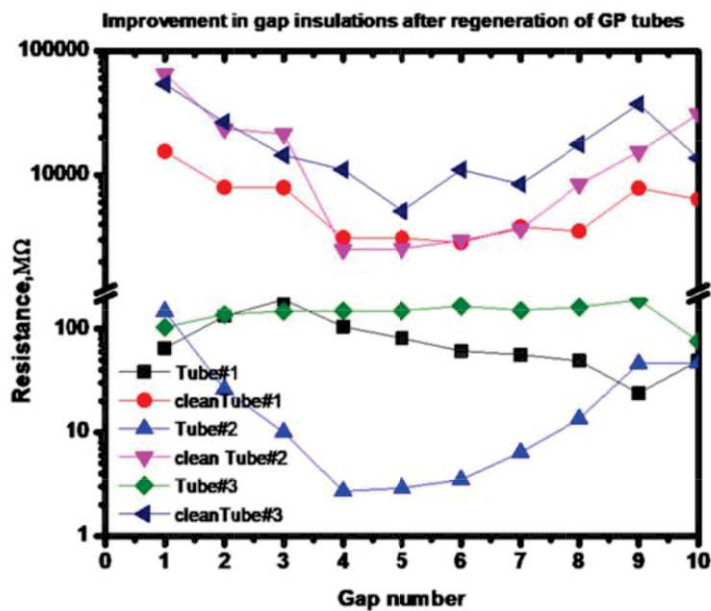
Figure 2: (a) Observed improvement in gap insulations after cleaning (b) the damaged coolant (LOBS) in solid form inside the reservoir.

GP tubes: All the three accelerating tubes were disconnected from the injector beam line. The tubes were regenerated through successive cleaning processes of sandblasting; cleaning with compress air, dipping in alcohol, cleaning with high pressure de-ionized water and in the end baking them in oven for 1 hour at 150°C. The ceramic gap insulations of the tubes were checked after every cleaning process with a 5KV Megger in air. After cleaning, the insulation gaps showed marked improvement up to few tens of Giga ohms. The results obtained are shown in figure 2(a). The three tubes were tested for any vacuum leak and subsequently assembled back with their electrodes.

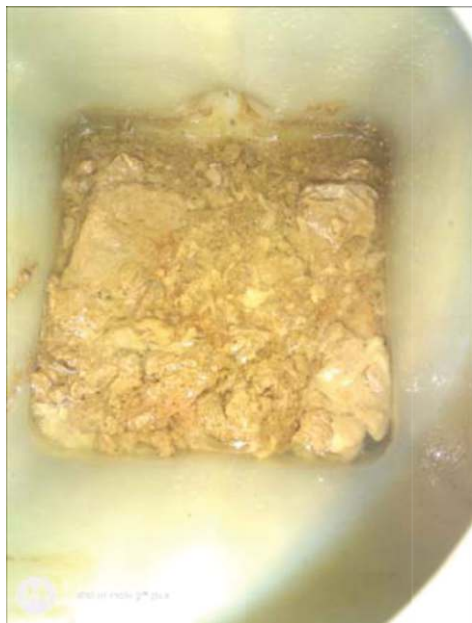
(b)

Ion source coolant: The coolant was found contaminated and we observed formation of solid lumps inside the coolant reservoir. It lost its insulation property and possibly forming a conducting path to the cathode voltage as well as the high voltage deck. The contaminated coolant was replaced with fresh coolant.

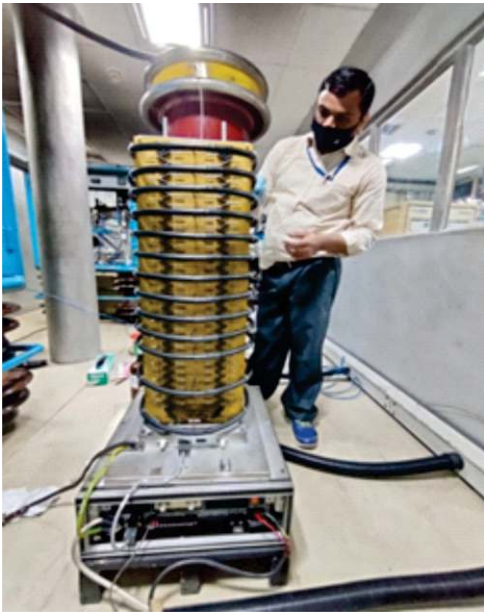
Figure 3. (a) Cleaning of Cockcroft Walton High Voltage multiplier, (b) Re-installed injector beam line.

Cockcroft Walton High Voltage multiplier: The toroid head of Cockcroft Walton voltage multiplier was dismantled. All the components of the voltage multiplier stack were thoroughly cleaned with alcohol, dried with compressed air and re-assembled. The normal operation and stability of the accelerator system with its highest acceleration voltage, 200KV was achieved after conditioning.

The injector beam line was reinstalled after regenerating its General Purpose accelerating tubes, ion source, extraction system and focusing lens. The re-installed beam line was checked to ensure that there was no vacuum leak. The beam line was pumped for creating vacuum and baked for 2 days. The resistors and toroids were mounted on the accelerating tubes after rechecking vacuum leak in the installed beam line.
