# 1. ACCELERATOR

## 1.1 PELLETRON

### 1.1.1 Operational Summary

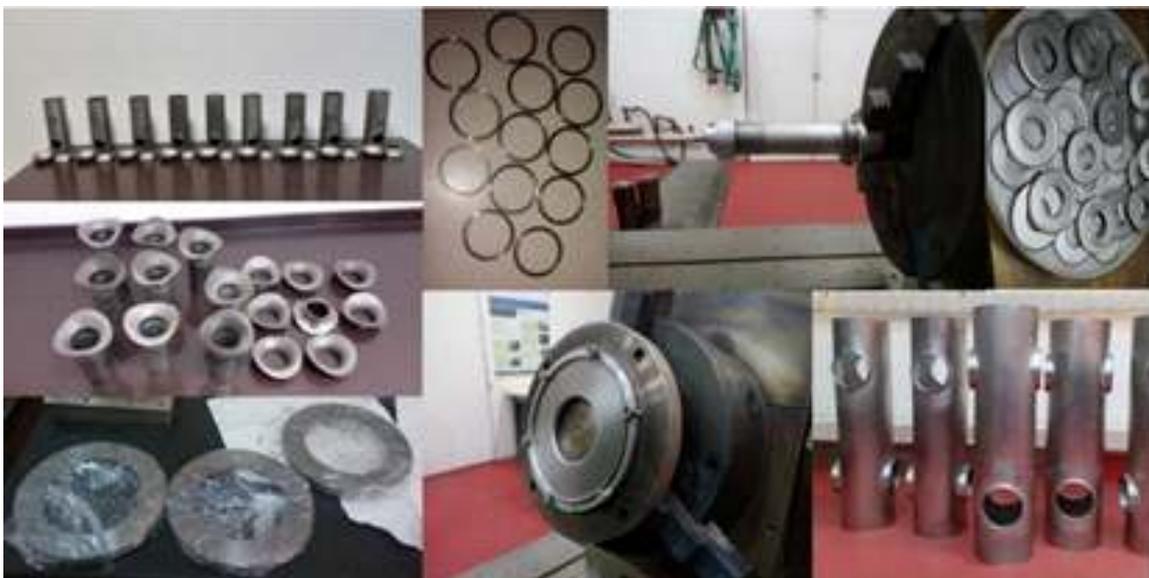
Figure 1: Clockwise from top-left: (i) elements of the niobium drift tube assemblies, (ii) weld rings for the slow tuner bellows, (iii) EBW set up for welding the drift tube beam port assembly, (iv) leaves for the slow tuner bellows, (v) SS outer helium vessels, (vi) EBW set up for welding slow tuner bellows, (vii) open-end flanges, and (viii) drift tube beam port assemblies before welding.

Construction of the six QWRs and additional slow tuner bellows as spares for the superconducting linac has progressed further. They will also be useful for conducting studies aimed at improving the accelerating gradient and quality factor in niobium quarter wave resonators as well as for other offline development works. Several parts / sub-assemblies for the resonators, e.g. the drift tubes assemblies, open-end flanges, slow tuner bellows, stainless steel outer helium vessels, etc. have been completed. In figure 1, several parts and sub-assemblies for the spare resonator construction are shown.

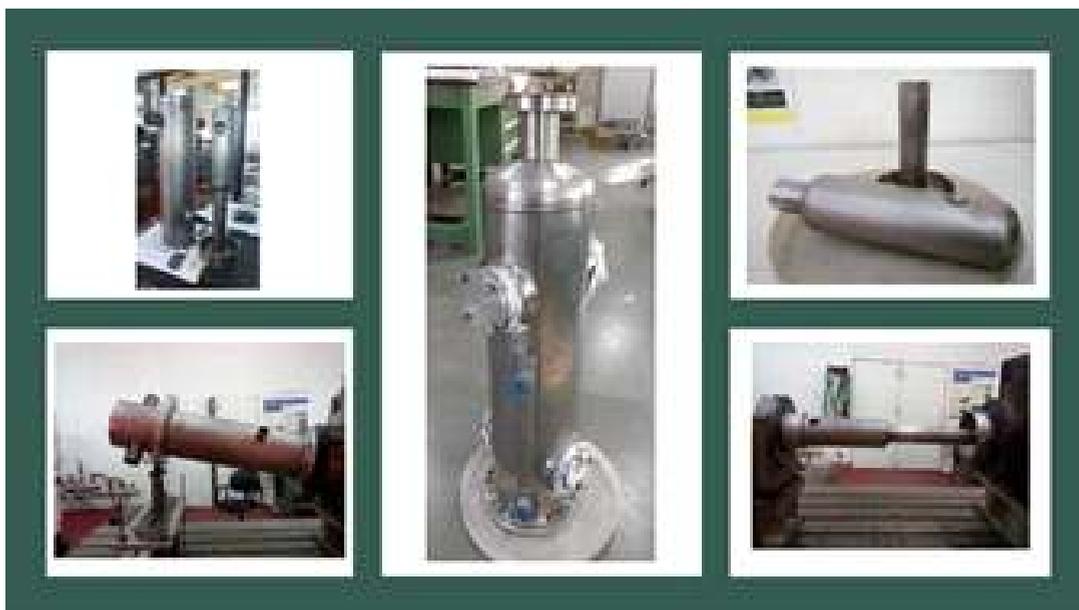
Figure 2: Centre: QWR-I11 after completion. Clockwise from top-right: (i) parts of the niobium central conductor – the loading arm with top flange (in the background) and drift tube (in the foreground), (ii) welding of the two parts of the central conductor, (iii) EBW of the niobium outer housing with the extension tube, (iv) the two major niobium sub-assemblies of the resonator before they were attached.

Systematic studies have been conducted to improve the achievable accelerating gradient and associated quality factor in QWRs using several different techniques [1]. In order to continue these studies, a quarter wave resonator; QWR-I11, which had been kept aside due to its high resonance frequency, has now been completed. The resonator had been cut open and its central conductor was shortened to the correct size to obtain the desired frequency. The resonator was electropolished and heat treated as part of the pre-test processing sequence. Subsequently the outer stainless steel helium vessel was installed. The resonator has been successfully leak tested and separately pressure tested in the test cryostat. In figure 2, the different stages of the reworking have been shown. We plan to initially test the resonator to establish a baseline test at 4K before subjecting it to further processing such as 650°C heat treatment, 120 °C baking, N-doping, N-infusion, etc. to study the improvement in its accelerating gradient and quality factor.

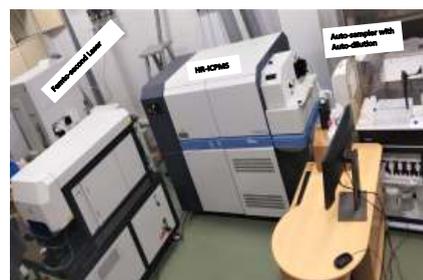
Figure 1: HR-ICPMS coupled with Fs Laser and Prefast auto-dilution system for automatic precise inline dilution (x 400)

HR-ICP-MS (model: Thermo Scientific, Element XR) coupled with femtosecond Laser Ablation (model: Teledyne), shown in fig. 1, is now extensively used for isotopic ratio measurements. The instrument can be used in solution mode, where a peristaltic pump is used to aspirate the sample or in solid mode, in which the femtosecond laser is used to ablate the sample and the aerosols generated are introduced into the mass-spectrometer for measurements. For doing sequence of samples in liquid mode automatically, the instrument is equipped with auto-sampler having 10 standard samples and 120 samples slot capacity.

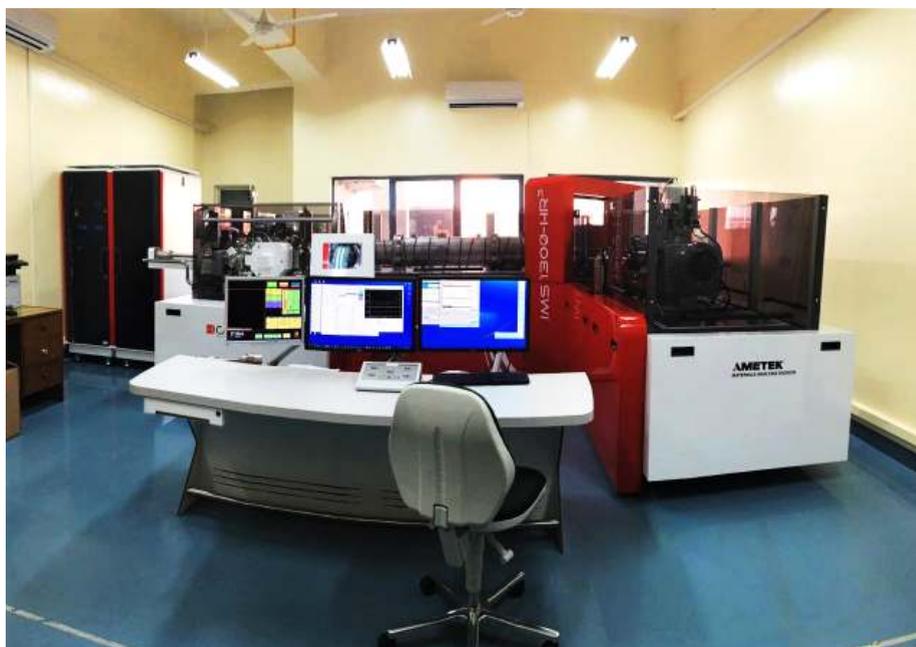
Figure 4: High Resolution Secondary Ion Mass Spectrometer (HR-SIMS)

negative and positive secondary ions, respectively. It has a Normal Incidence electron Gun (NIG) for compensating the accumulation of positive charges on the sample. For sputtering, vacuum at the sample surface is very important and the analysis chamber has the vacuum of the order of  $10^{-10}$  mbar.

The samples before analysis can be outgassed in the storage chamber having capacity of storing six samples under vacuum of the order of  $10^{-8}$  mbar so that vacuum of the analysis chamber doesn't degrade on loading the sample from storage chamber into it. The loading of the samples from the storage chamber to analysis chamber can be done by just one click from the software. This mass spectrometer has one Electro Static Analyzer (ESA) which does energy filtering followed by one magnet which does the mass separation.

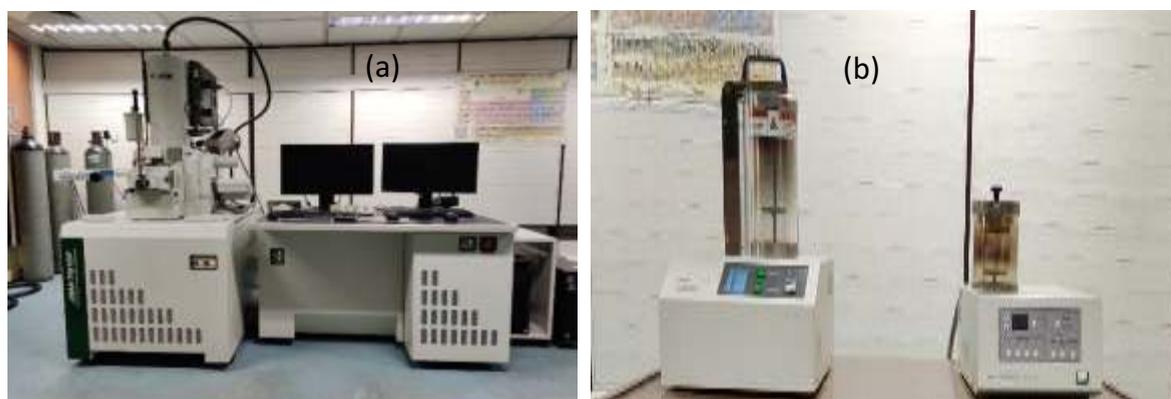
Figure 6: FESEM image (a) JEOL JSM-7610F, (b) Carbon-rod evaporator and Platinum sputter target

Sputter conductive coatings (either metal or carbon) is a sample preparation instrument for use with FESEM. Our coating instruments include JEC-3000FC (JEOL make) capable of coating platinum and EC-32010CC (JEOL make) carbon rod evaporator shown in figure 6. Electrically conductive coating prevents charging of specimen and causes the enhancement of secondary electrons which further causes the enhancement of signal to noise ratio.

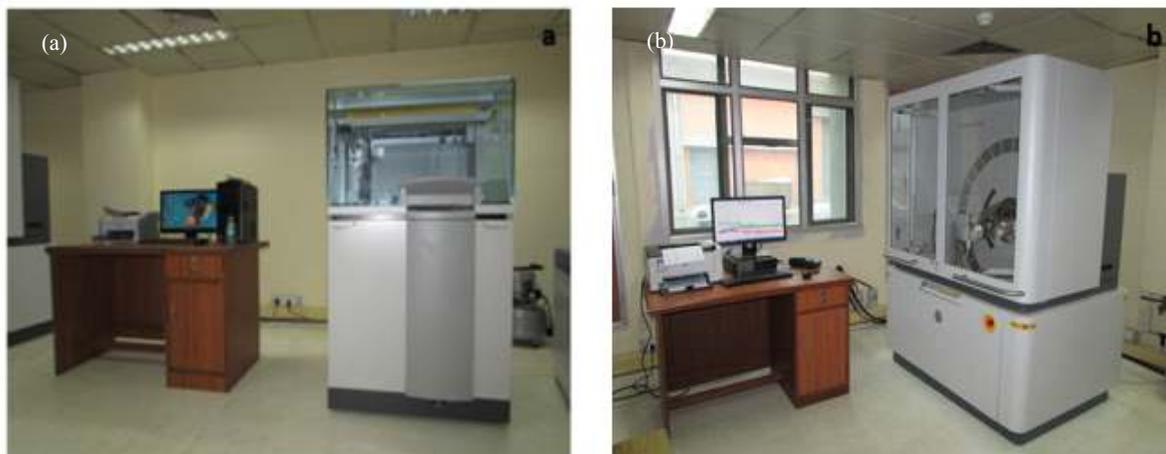
Figure 9: (a) X-Ray diffractometer and (b) WD-X-ray Fluorescence Spectrometer

X-ray diffractometer is non-destructive and powerful tool to characterise a crystalline material with minimum sample preparation requirement. Powder X-ray diffraction method is used to determine mineralogy of different geological samples (e.g. clay, sediments etc.) collected from different locations around the country and for phase identification of synthesised crystalline materials. Resulting XRD patterns provide information about the phase lattice structure, absorption, porosity and degree of crystallinity of the minerals/phases identified. X rays diffractometer has been operational since 2017 and being utilized routinely by users for characterization of their samples. 859 samples of 29 users from 15 different universities and 3 institutes, were analysed using XRD. These analyses helped the users to understand the phase formation and transformations under different paleoclimatic changes, depositional environments and Earth surface processes, etc. Figure 9 and 10 show XRD and WD-XRF instruments at IUAC. Figure 10 shows equipment related to the sample preparation for WD-XRF system.

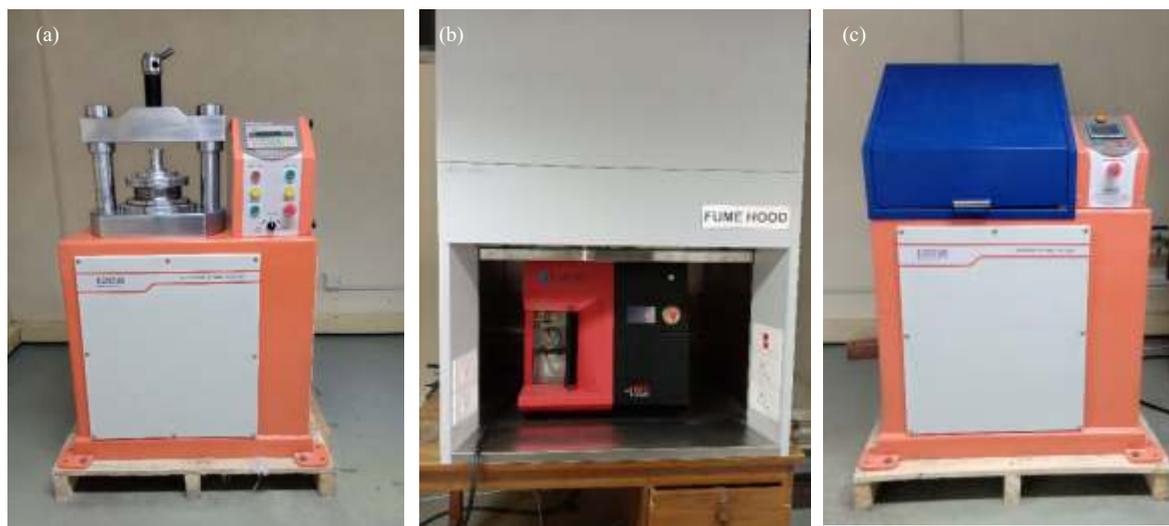
Fig: 10: (a) Pellet Press Machine (b) Fused bead Machine (c) Vibratory cup mill

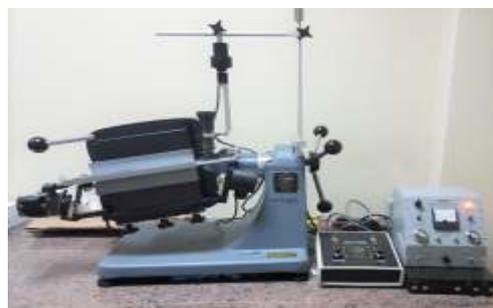
Fig. 11: Magnetic barrier separator at IUAC

Most of the minerals fall under three categories of magnetic properties; ferromagnetic, Paramagnetic and Diamagnetic minerals. Magnetic barrier separator uses magnetic field and gravitational field to separate a particular mineral from the mineral mixture. The magnetic separator has a large electromagnet through which mineral mixtures is passed on an inclined metal plate. By varying the magnetic field value and/or the slope of the metal plate, the minerals of different magnetic properties can be separated from one another. Isodynamic separator placed at IUAC is shown in figure 11. This system was commissioned in June 2019 and about 20 samples have been processed for quartz separation for the purpose of CRN dating.

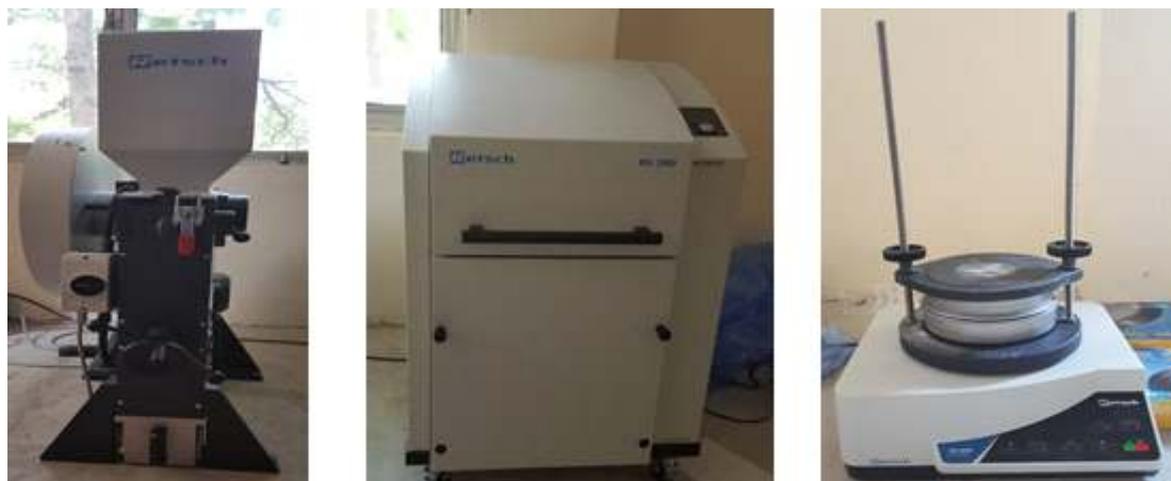
Figure 12: Jaw crusher, vibratory disc mill and sieve shaker

Rocks must be broken into suitable sizes prior to crushing. Jaw Crusher is used for crushing large size samples (< 9 cm) to smaller sizes (~ 2 mm). Rock size bigger than 9 cm are broken into small pieces using hammer or any other suitable instrument.

Sieve shaker contains stack of sieves of different pore sizes. The Sieve stack is mounted on the vibratory platform, where the speed and duration of vibration can be adjusted. Sieves of various mesh sizes are used for sieving purposes.
