1. ACCELERATOR

1.1 PELLETRON

1.1.1 Operational Summary

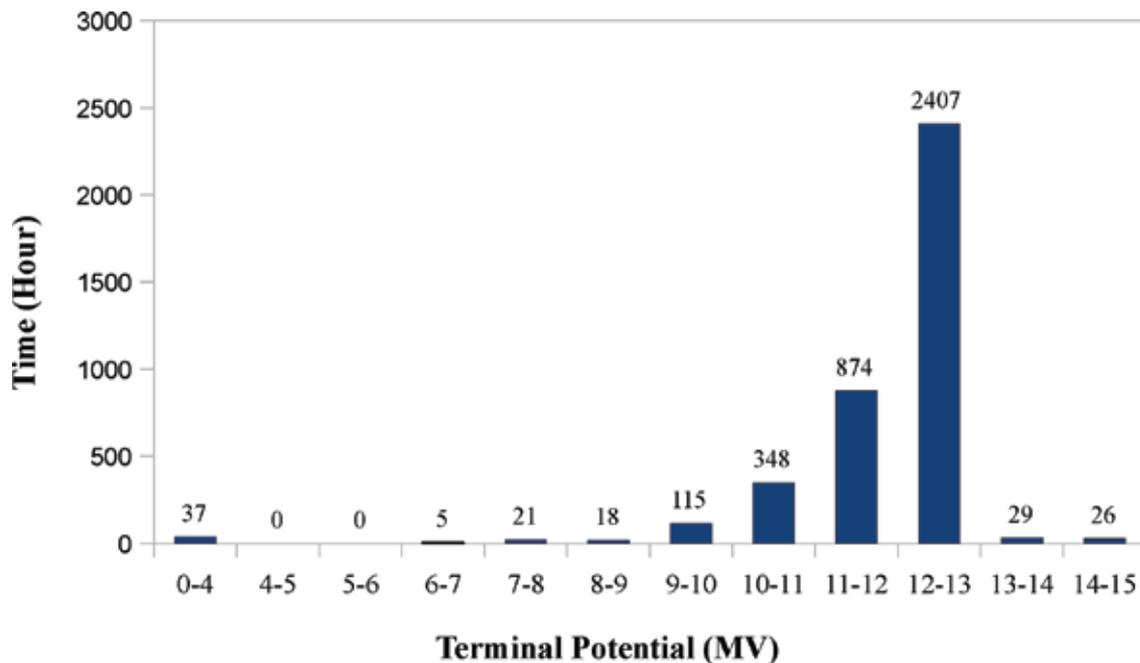
Fig. 1. Terminal Potential vs. Hour Graph

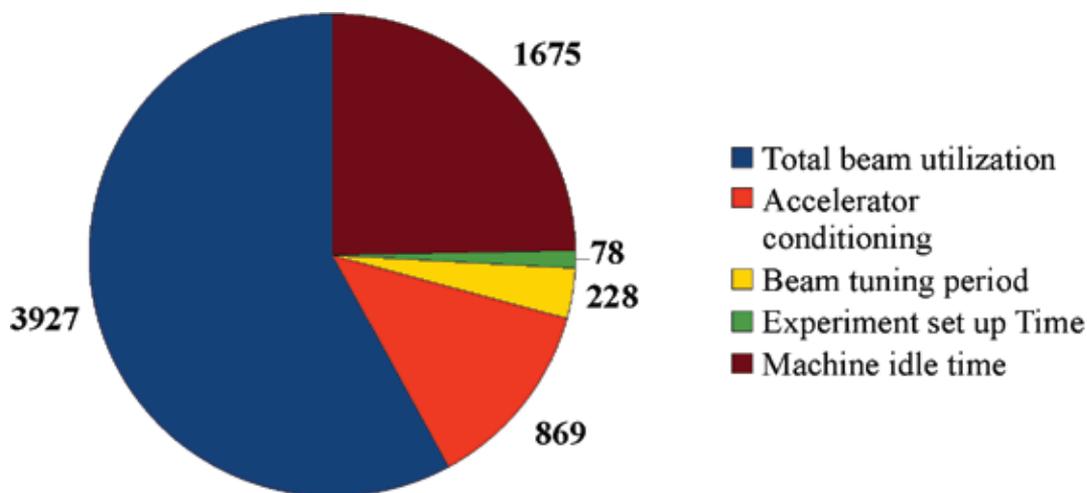
Accelerator performance, in the form of Pi-chart, is shown as below in figure 2.

Fig. 2. Chain Hours Utilization

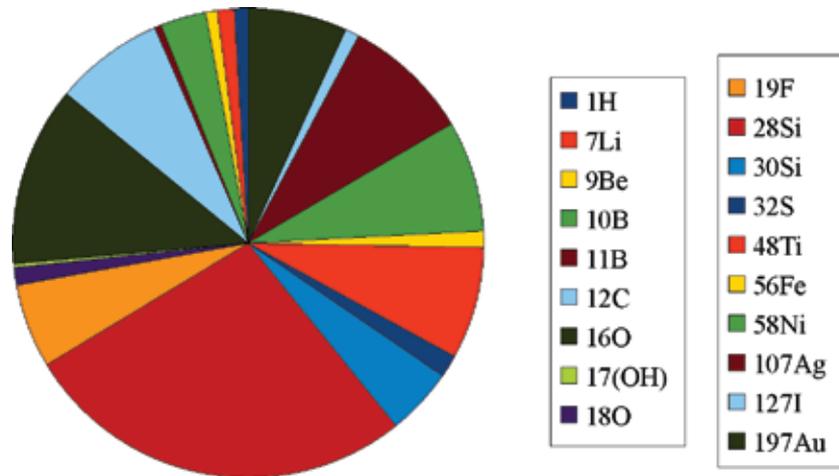
Pi- chart in figure 3 shows the distribution of delivered beam species during beam run from 1st April 2012 to 31st March 2013.

Fig. 3. Distribution of delivered ion beams

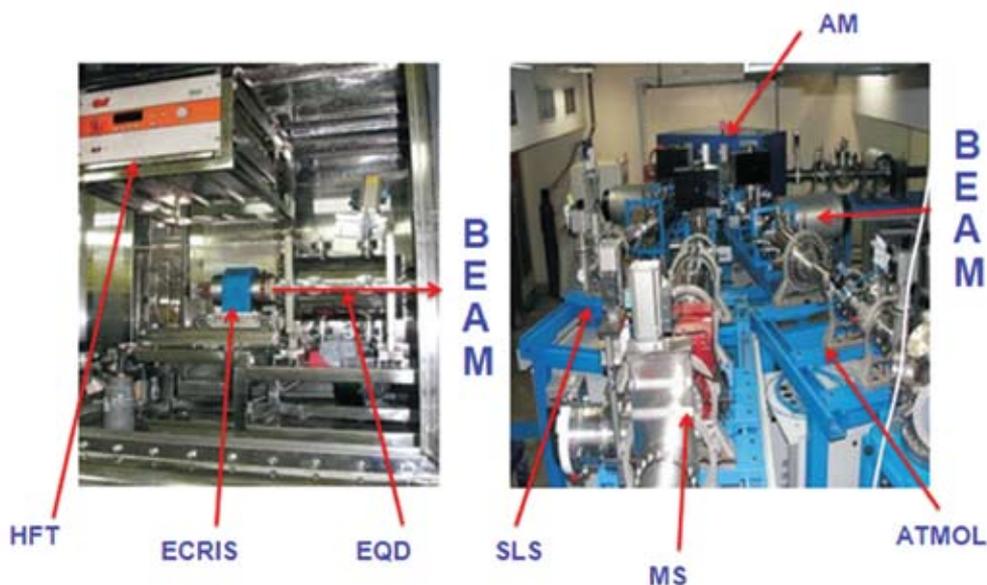
Fig. 1. All permanent-magnet-ECR source along with peripheral electronics on high voltage platform and view of the beam hall. HFT and AM stands for high frequency transmitter and analyzer magnet respectively. Others abbreviations used in the figure are already explained.

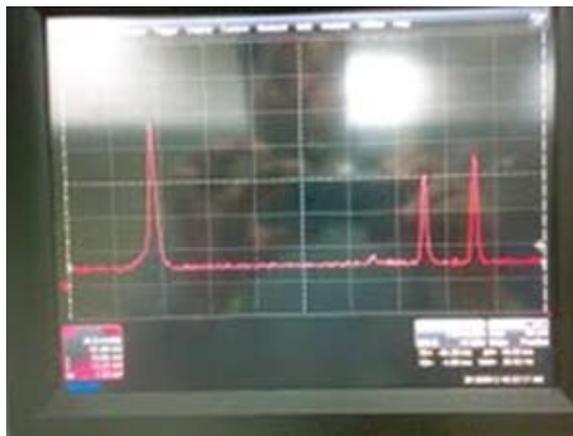
Fig. 2. A typical profile of 500 keV Xe⁺² beam

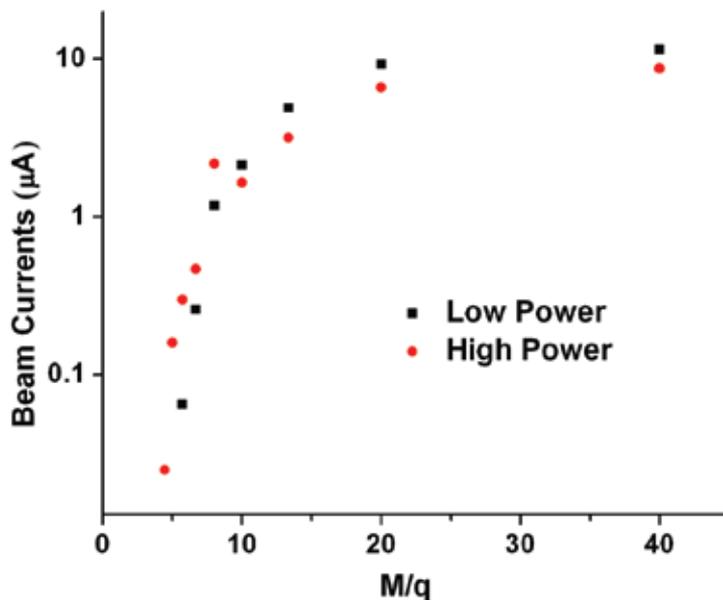
Figure 3 shows the charge state distribution (CSD) of argon ECR plasmas at E/q = 212 kV (platform voltage = 200 kV and extraction voltage = 12 kV) and two different power levels - 2 and 70 watt. At 70 watt of RF power, we could populate up to + 9 charge state of argon which was limited to +7 for 2 watt power. Beam current for first few charge states are limited to tens of micro-amp due to the fact that we have used apertures (1 inch in diameter) in the first and third units of accelerating column to avoid the beam hitting and sputtering of the guard rings which caused deposition of metallic layer between two high voltage ring electrodes. Simulations show that only 13% beam will be allowed through accelerating column.

Fig. 3. Charge state distribution (CSD) of argon at E/q = 212 kV and two power levels (2 and 70 watt).

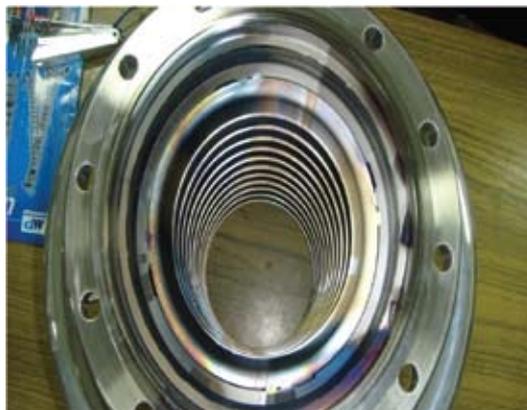
Fig. 4. Inner View of an accelerating unit. Beam marks on guard rings are clearly visible.

Major maintenance work in this academic year includes dismantling of 400 kV accelerating column from beam line & its re-installation after sand blasting of its inner surface and repairing of 400 kV power supply. 400 kV accelerating column consists of 5 units (10 gaps in each unit). Due to quite high beam current through accelerating column, we could see signature of sputtering of metallic guard rings placed inside accelerating column which further caused deposition of metallic layer between insulating gaps and we could not raise high voltage beyond certain limit. Accelerating column was taken out of beam line for removal of deposited metallic layer. To avoid such problem in future, two apertures (at unit 1 and 3 from source side) were attached to the column before installing it again in the beam line. With aperture, total and analyzed beam currents reduced drastically but were sufficient for typical experiments proposed with LEIBF. Inner view of an accelerating unit is shown in figure 4.

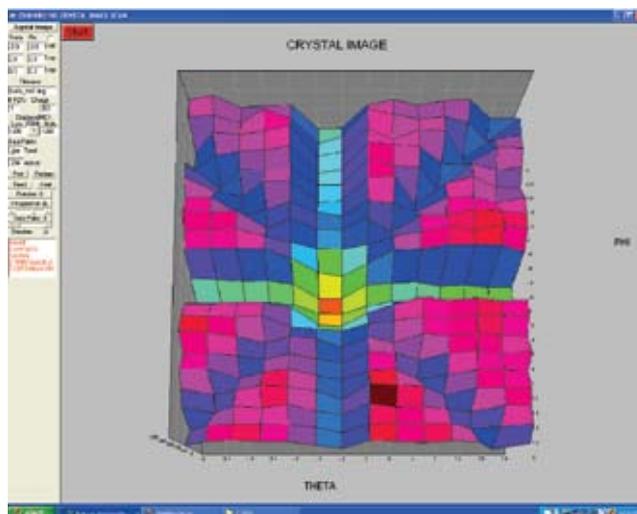
Fig. 1. Channeling image scan of GaAs (100) crystal

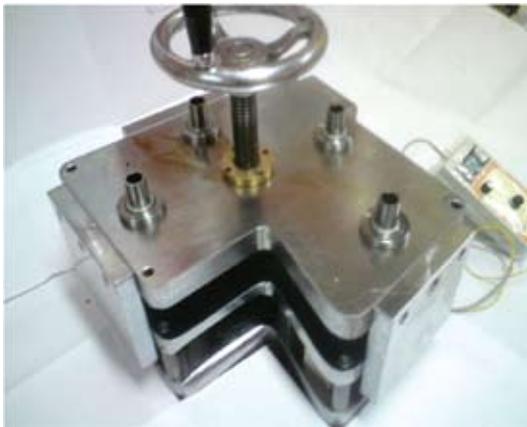
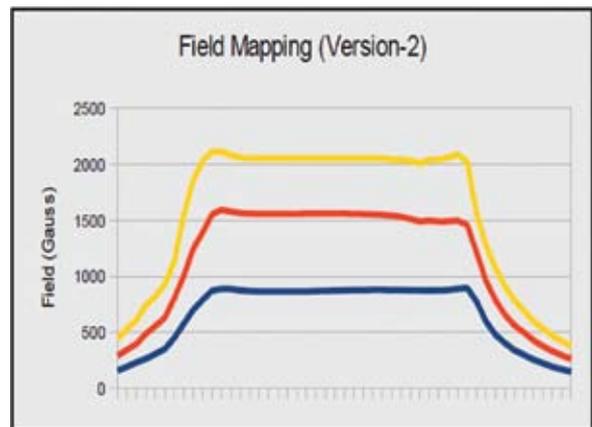
The bending magnet for 50 keV Accelerator has been re-designed and assembled using 50x25x10 mm permanent magnet pallets of 4 kG surface flux density. The new design uses 25 mm thick MS plates and a common hand wheel to vary the field in place of individual bolts for field variation. Shorting plates around the poles mounted on a common plate have been used to vary the field. The magnet has beam pipe of cross section 60x75 mm across the magnet with a bending radius of 200 mm. A maximum field of 2110 Gauss is achieved with this design which can be varied down to 900 Gauss by moving the hand wheel. Field mapping is carried out and found to have quite homogeneous field throughout the region between the poles as shown in the figure below.

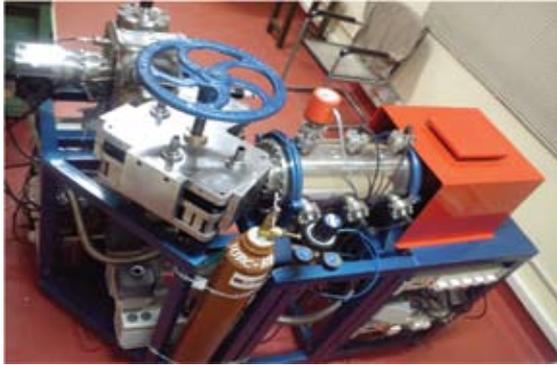
Front View

With development of new bending magnet & electrostatic quadrupole triplet etc the different components are assembled on a common stand. Penning ion generator is mounted at the inlet flange of quadrupole itself. The vacuum pumps, power supplies etc are installed, wired and tested. PLC based controller was assembled for controlling the electrostatic quadrupole. Complete Ion Accelerator with a gate valve & small experimental chamber is tested. Hydrogen & helium gas is used to produce beams. Performance tests are carried out at complete range of energy & current as shown in the figure. The long time stability tests are also performed.

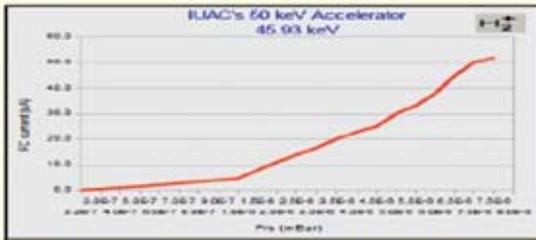
Beam Current Vs Source Prs. At 49 kV, 1721 G

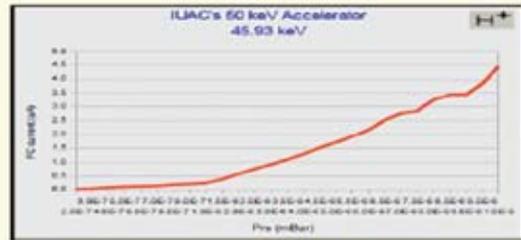
Beam Current Vs Source Prs. At 49 kV, 1230 G

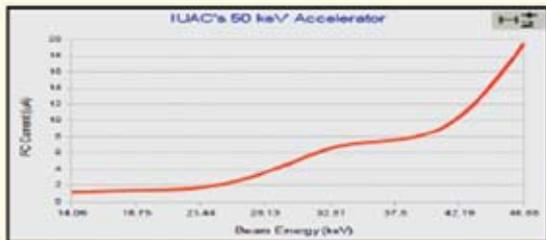
Beam Energy Vs Current at fixed Prs.

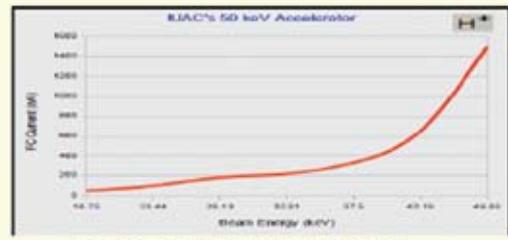
Beam Energy Vs Current at fixed Prs.

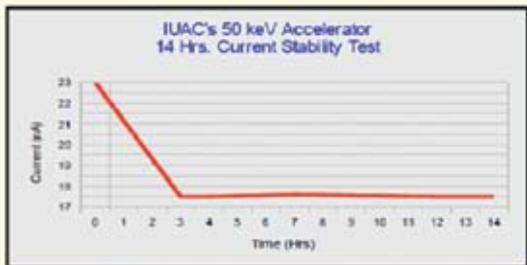
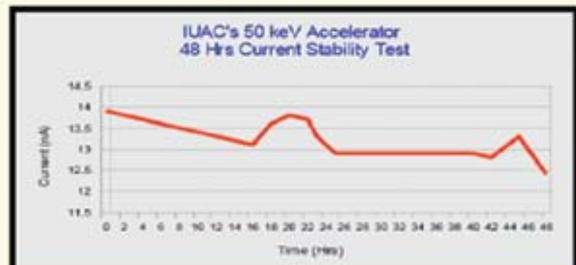
Beam Current Stability Tests
